## FACILITY COMPLIANCE INSPECTION REPORT

### Division of Waste Management Solid Waste Section

**Date of Site Inspection:** February 11, 2014

Yadkin County Solid Waste Transfer Facility  
1149 Landfill Road  
Yadkinville, North Carolina 27055

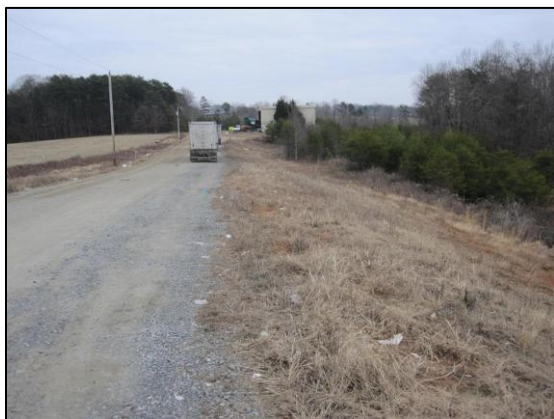
During the inspection, severe windblown waste was observed on each side of the access road leading to the transfer station, within the rip rap areas on each side of the transfer station, along the access road leading around the back of the facility and within the area designated for storage of roll-off containers. Therefore, Yadkin County and Republic Services of North Carolina, LLC are in violation of 15A NCAC 13B .0402(7) and Operating Condition #7(e)(ii).

View of windblown waste along access road.

**To achieve compliance, within 10-days of receipt of the Notice of Deficiency, all windblown waste surrounding the transfer station and along the access road to the facility must be picked up and returned to the transfer facility.**

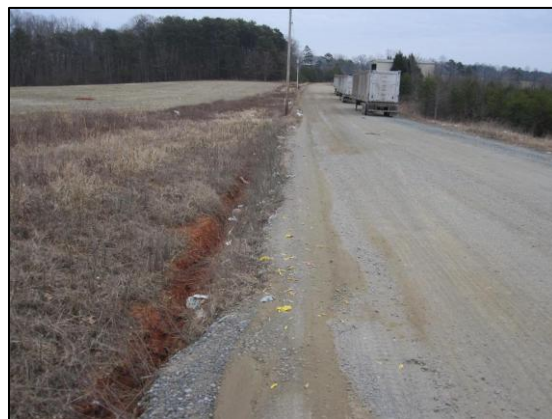
Second view of windblown waste along access road.

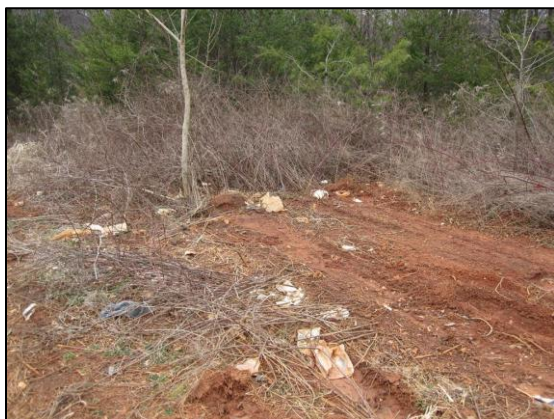
View of waste on ground at storage area for roll-off containers.

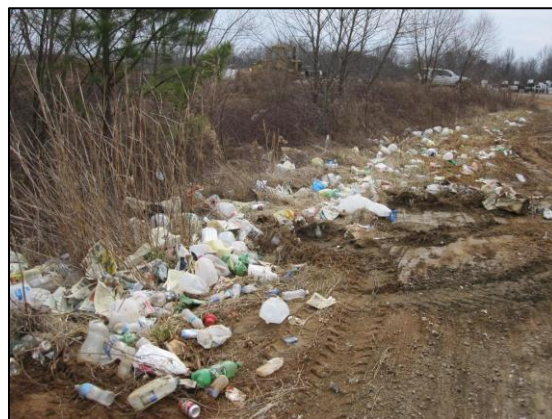
Yadkin County is in violation of 15A NCAC 13B .0203(d) and General Condition #17 of the Permit to Operate in that windblown waste was observed on the surrounding the trailers and along the vegetated area east of the recycling area. This material consisted primarily of plastic bottles and paper and appeared to originate from the storage bays for recyclables.

Windblown waste on ground east of recycling area.

**To achieve compliance, within 10-days of receipt of the Notice of Deficiency, all windblown waste resulting from recycling activities must be picked up and returned to the designated disposal area. Steps must also be taken to prevent future incidents of recyclables being deposited by wind outside of the designated recycling area creating a nuisance. Action can include, but not be limited to, reinstalling the retaining nets at the entrance to each recycling bay. Only one net was in place during the inspection.**
